WELDING INSPECTION REPORT

Project Name: SAS Superstructure **OSM Arrival Time:** 700 **OSM Departure Time:** 1900 **Prime Contractor:** American Bridge/Fluor Enterprises, a JV

Bridge No: 34-0006 **Component:** Tower

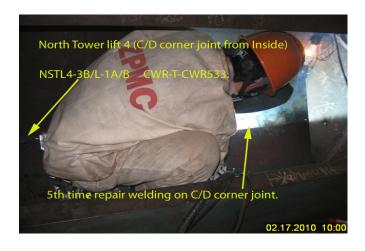
This QA Inspector observed ZPMC qualified welding personnel identified as 057258, Perform Shielded Metal Arc Welding (SMAW) on North Tower lift 4 B/C corner joint. The weld identified as NSTL4-3B/L-5B, Y location is 26750. ZPMC CWI Identified as Gang Liang Zhu, with Temporary welding repair report. The welding parameters as measured using QC's calibrated instrument appeared to be in general compliance with WPS-345-SMAW-2G (2F) - Repair. For more information see attached photos.

This QA Inspector observed ZPMC qualified welding personnel identified as 066236, Perform Shielded Metal Arc Welding (SMAW) on North Tower lift 4 B/C corner joint. The weld identified as NSTL4-3B/L-5B, Y location is 12100. ZPMC CWI Identified as Gang Liang Zhu, with Temporary welding repair report. The welding parameters as measured using QC's calibrated instrument appeared to be in general compliance with WPS-345-SMAW-2G (2F) - Repair. For more information see attached photos.

This QA Inspector observed ZPMC qualified welding personnel identified as 040434, 066733 Perform Flux Core Arc Welding (FCAW) on North Tower lift 4 C/D corner joint. The weld identified as NSTL4-3B/L-1A/B, near double Diaphragm 123M and 127M. Y location is 23670 to 235530mm and 19380 to 18590mm. ZPMC CWI Identified as Du Zhi Quin, with Critical welding repair report, CWR -T-CWR533. The welding parameters as measured using QC's calibrated instrument appeared to be in general compliance with WPS-345-FCAW-1G (1F) -Repair. For more information see attached photos.

This QA Inspector observed ZPMC qualified welding personnel identified as 066361, 066038 Performing Shielded Metal Arc Welding (SMAW) on West Tower lift 4 B/C corner joint from Inside. The weld identified as WSTL4-2B/L-58B, In Between double Diaphragm 131M to 135M, and 123M to 127M. ZPMC CWI Identified as Lilin, with Critical welding repair report, CWR –T-CWR569. The welding parameters as measured using QC's calibrated instrument appeared to be in general compliance with WPS-345-SMAW-2G (2F) - Repair. For more information see attached photos.
